BNL Update 11/8/2016

Injection Molded Lightguides Q/A

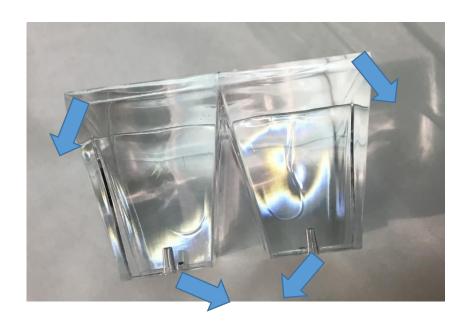
- Noted that many of the pieces have deformed (since arrival?)
- Tapped holes have moved by as much as 1mm, so would not fit with sipm/pcb.
- First 2-3 taken, machined and polished have not deformed significantly Does machining reduce thermal stress in part?
- ProtoLabs Process engineer and materials engineer say that effect is due to part thickness. Parts this thick may take 2-3 days to set.
- We have ~10 that have been machined and polished for the prototype.
- We considered ordering a second batch of the 1" LG's and then machining them quickly after they arrive. But since we already have enough for ½ of the prototype – it would be more productive to move ahead with the longer version.
- Tentative plan is to order 100 w/ expedited delivery, then machine them quickly once they arrive at BNL.
